Alfresco™

URS-1 SERVICE AND PARTS MANUAL

SERIAL NUMBERS: 06-10679 TO 08-16900.

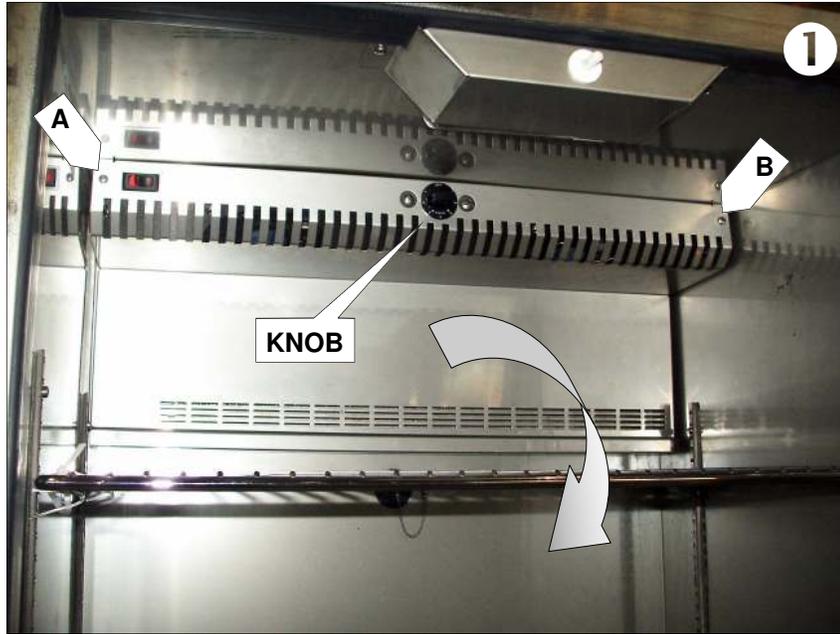
1

To replace the RANCO Thermostat, (SES part # 210-0023) open the evaporator coil cover by removing the thermostat knob (pull out) and then the mounting screws A & B shown on the picture below.

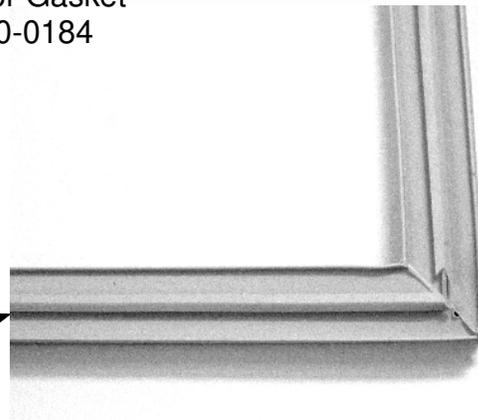
Magnetic Door Gasket
Corner Detail
